BODY WORKS

IF YOU DON'T KNOW YOUR ABS FROM YOUR MONOCOQUE, LET **JOHN WICKERSHAM** UNCOVER THE SECRETS OF YOUR BODY

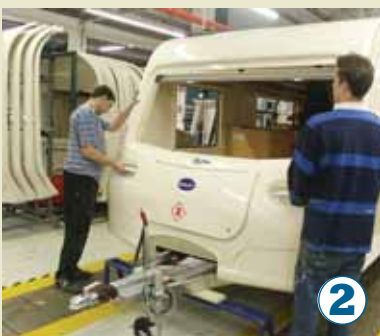
1 The stunning, graphic-embellished blue sides of this 2005 Sun Ti might be quite costly to repair

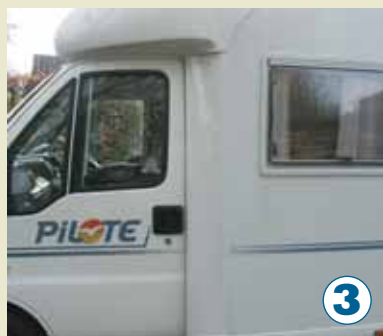
2 Most new caravans are fitted with an acrylic-capped ABS plastic front; few manufacturers fit GRP panels

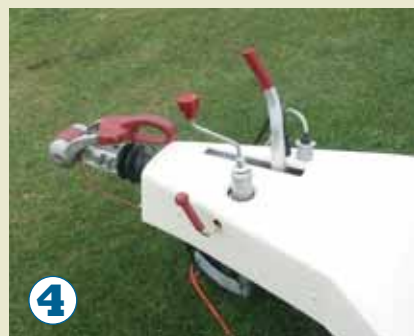
3 The ABS upright panel along the rear of this cab door had cracks around some of its fixings

I'm pleased the material still retains a prominent place in coachbuilt motor caravan construction, although that is changing, too. I recently tested a 2005 Pilote Reference motor caravan and vertical ABS mouldings were installed adjacent to the cab doors. To my surprise, cracking was evident around the pin fixings holding them in place.

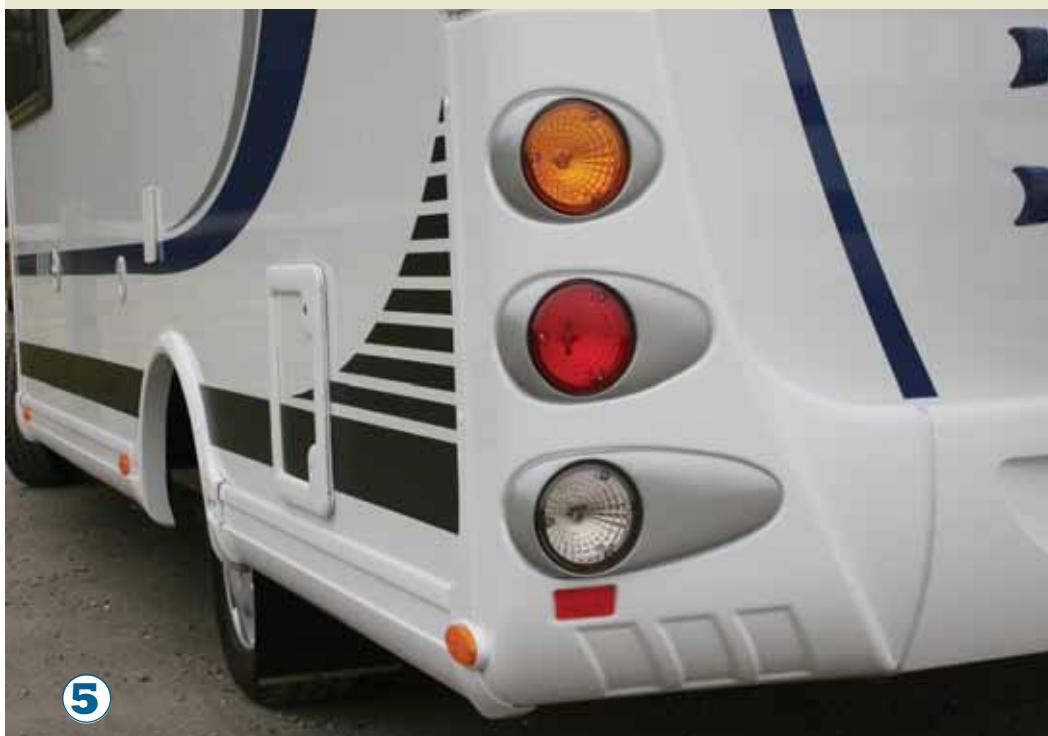
5 Side skirts and the moulded rear light panel on this Dethleffs model are made in ABS plastic

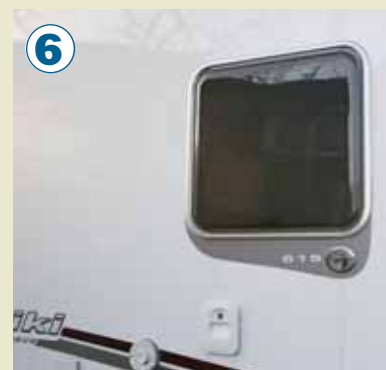
6 This new Kon Tiki Vogue is clad in GRP sheet which can be repaired by skilful plastics specialists

first caravan to be clad in this impact-resistant body skin instead of sheet aluminium. Today it's also used on several motor caravans like Swift and Bessacarr models, and skilful specialists can repair localised damage.

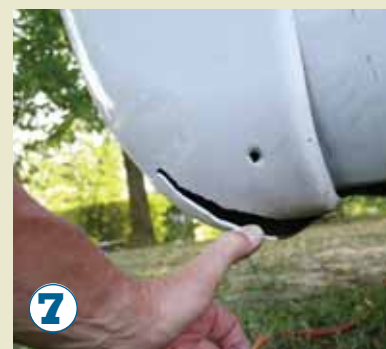
7 If a replacement ABS panel is unavailable, damage like this can be repaired – and it's not difficult

On barely visible side skirts, wheel spats or rear spoilers, I've patch-repaired ABS using Sikaflex 512 adhesive sealant and a surface-filling compound. For more permanent results, it's better to use purpose-formulated ABS repair kits but these cost around £100.

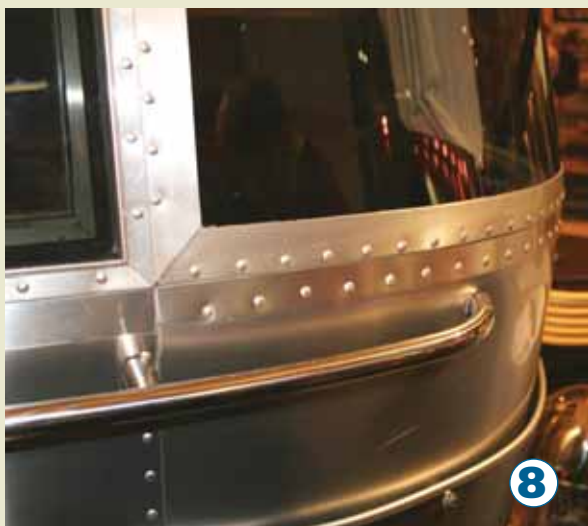
8 Replacing a damaged panel on an Airstream caravan would be a job for skilled panel beaters

I imagine it's far more involved (and costly) to carry out accident repairs on an Airstream caravan. You can neither knock out a dent nor paint over a bonded patch. Presumably a new panel has to be riveted in place of the damaged original one – a job needing special skills.
