Access Statement

Kinlochewe

Caravan and Motorhome Club – Kinlochewe

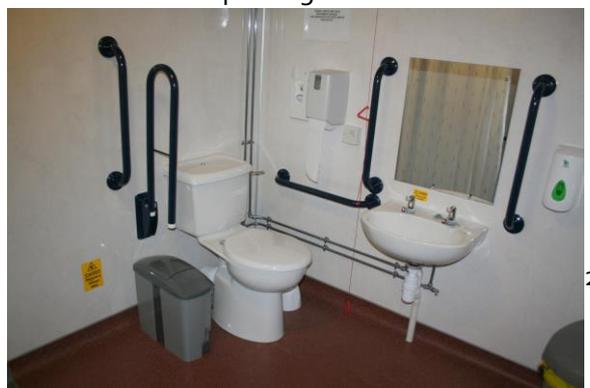
The **accessible WC and shower** cubicle is located to the side of the toilet block with a separate entrance, which is opened using a standard key. This facility has step-free access via a

ramp with suitable gradient but the handrail is to one side only and the tactile warning surface could cause confusion for people with a visual impairment. The door is outward-opening, light to open with a flush threshold, and it can be opened from the outside if someone falls against it in an emergency. The room has generous circulation space of 2200mm wide x 3000mm deep, with anti-slip tiled floor. The WC and washbasin layout are generally to AD M standards. The washbasin has individual taps (no mixer) and there are no paper towels. There is very good contrast between elements in this room.
