## **Access Statement**

### **Knareborough**

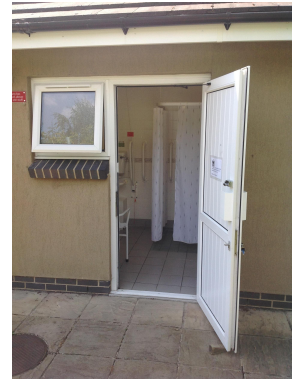
The **accessible WC and shower** is in a separate room to the front of the toilet block with level access; a short crushed stone path offers a shorter but more difficult access route. The room is well equipped and to a good level of design and specification although the alarm reset button is remote from WC and shower. The WC is for right-hand transfer and the shower for left-hand transfer; the shower is fitted with a drop-down seat and a shower head that is adjustable for height. The washbasin does not have vertical grab rails and there is little contrast to any of the grab rails against the white tiled background. The shower chair in the room and two large waste bins tend to restrict the circulation space which is otherwise adequate for wheelchair users. The lock is rather difficult to operate.
