Access Statement

Salisbury Hillside

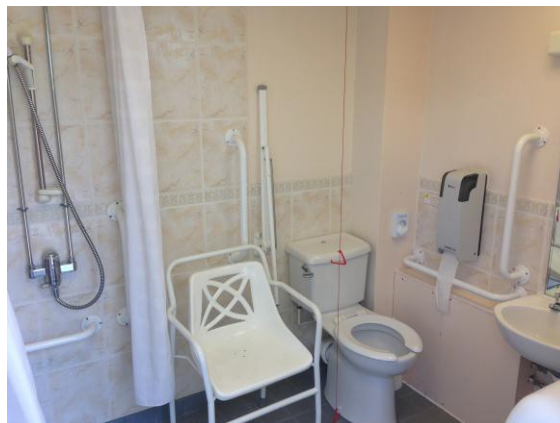
There is a combined **accessible WC and shower** located adjacent to the other toilets and accessed using a RADAR key. The outward-opening door has a level threshold and a 900mm clear opening. The room is small, with shower/drying chair stored in the toilet transfer area. The toilet is left-hand transfer and the shower is right-hand transfer, and there are grab rails provided to assist. An alarm system is provided. Taps and controls are lever non-mixer type.
